Proposal
Lake Michigan Property Owners'
Sea Wall Proposal

Sea Wall Project 2020 - 2021

Smolik, Burrows, Gosnell Cottages

Presented to the Congregational Summer Assembly

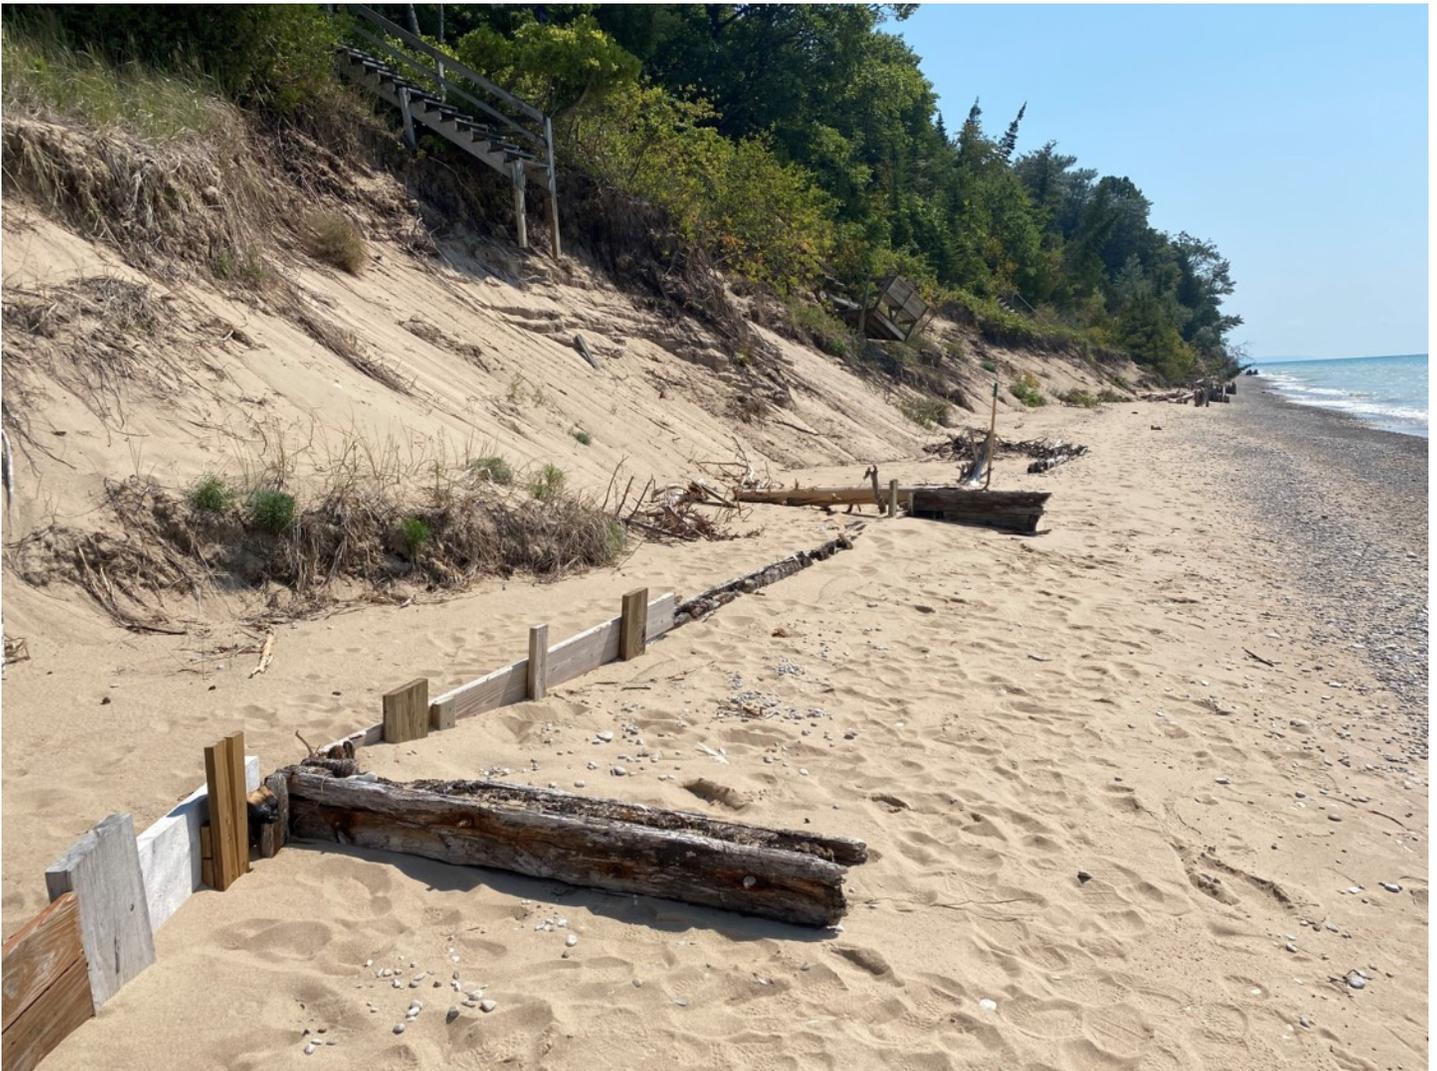
Remnants of Existing Wooden Wall
From North End of Gosnell Property
(looking south)

This sea wall provided protection for some time, but the rise in lake levels, along with very strong wave action, has created a much more dangerous situation than in 1986. The “cliff” is several times higher, access stairs to the Lake have been destroyed, and the property lines of the above owners are now truly threatened. The major portion of the wooden wall has been virtually destroyed; in some areas some remnants remain, in others not. Parts of the existing wall, especially on the south end, are so damaged as to be irreparable. See Figure One of the enclosed PowerPoint presentation for visual evidence.

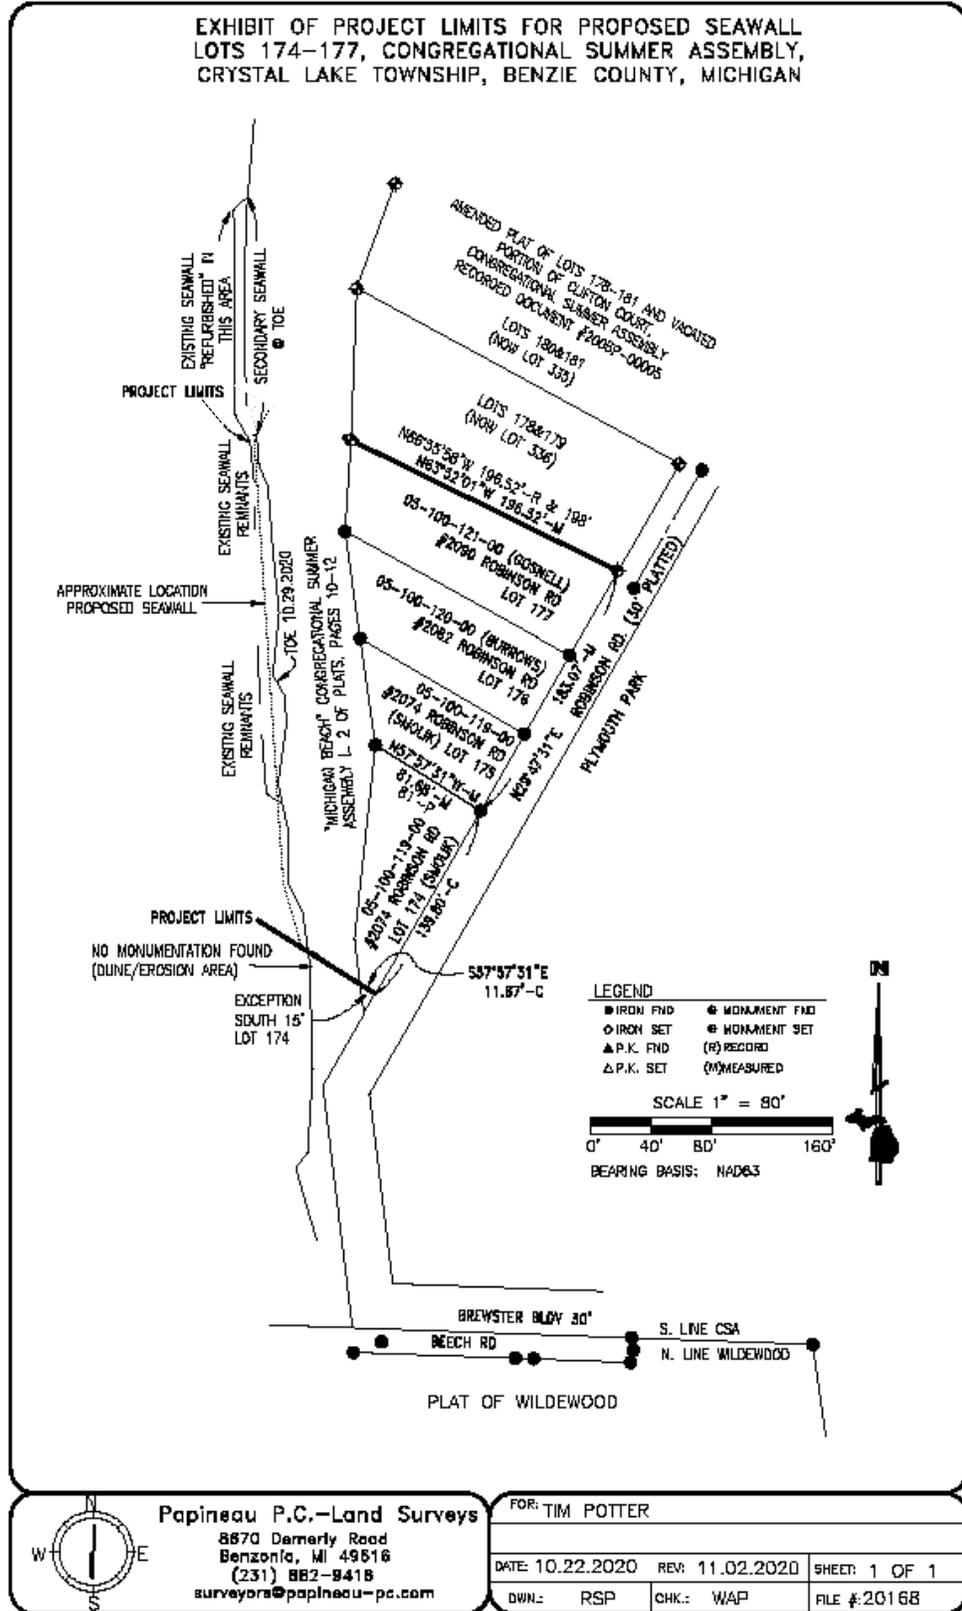
Figure Two

Survey of Cottage Lots, Existing and Proposed Sea Walls

Proposal The Owners propose to have constructed on the common property beach of the Congregational Summer Assembly (CSA) a continuous sea wall of sheet pile design. Figures Two and Three of the presentation describe the layout of this wall. It will generally follow the path of the remains of the wooden sea wall, but be a few feet to the landward side (typically 5’). At the north and south ends of the wall, the wall will turn landward on a 45-degree angle (to mitigate “scouring” wave action from the side). On the north end of the wall, the wall will tie into the Rauth’s repaired wooden wall, providing a solid front. In total, the wall will be approximately 300’ long. The work would all be performed by Gilbert Excavation of Arcadia, MI,

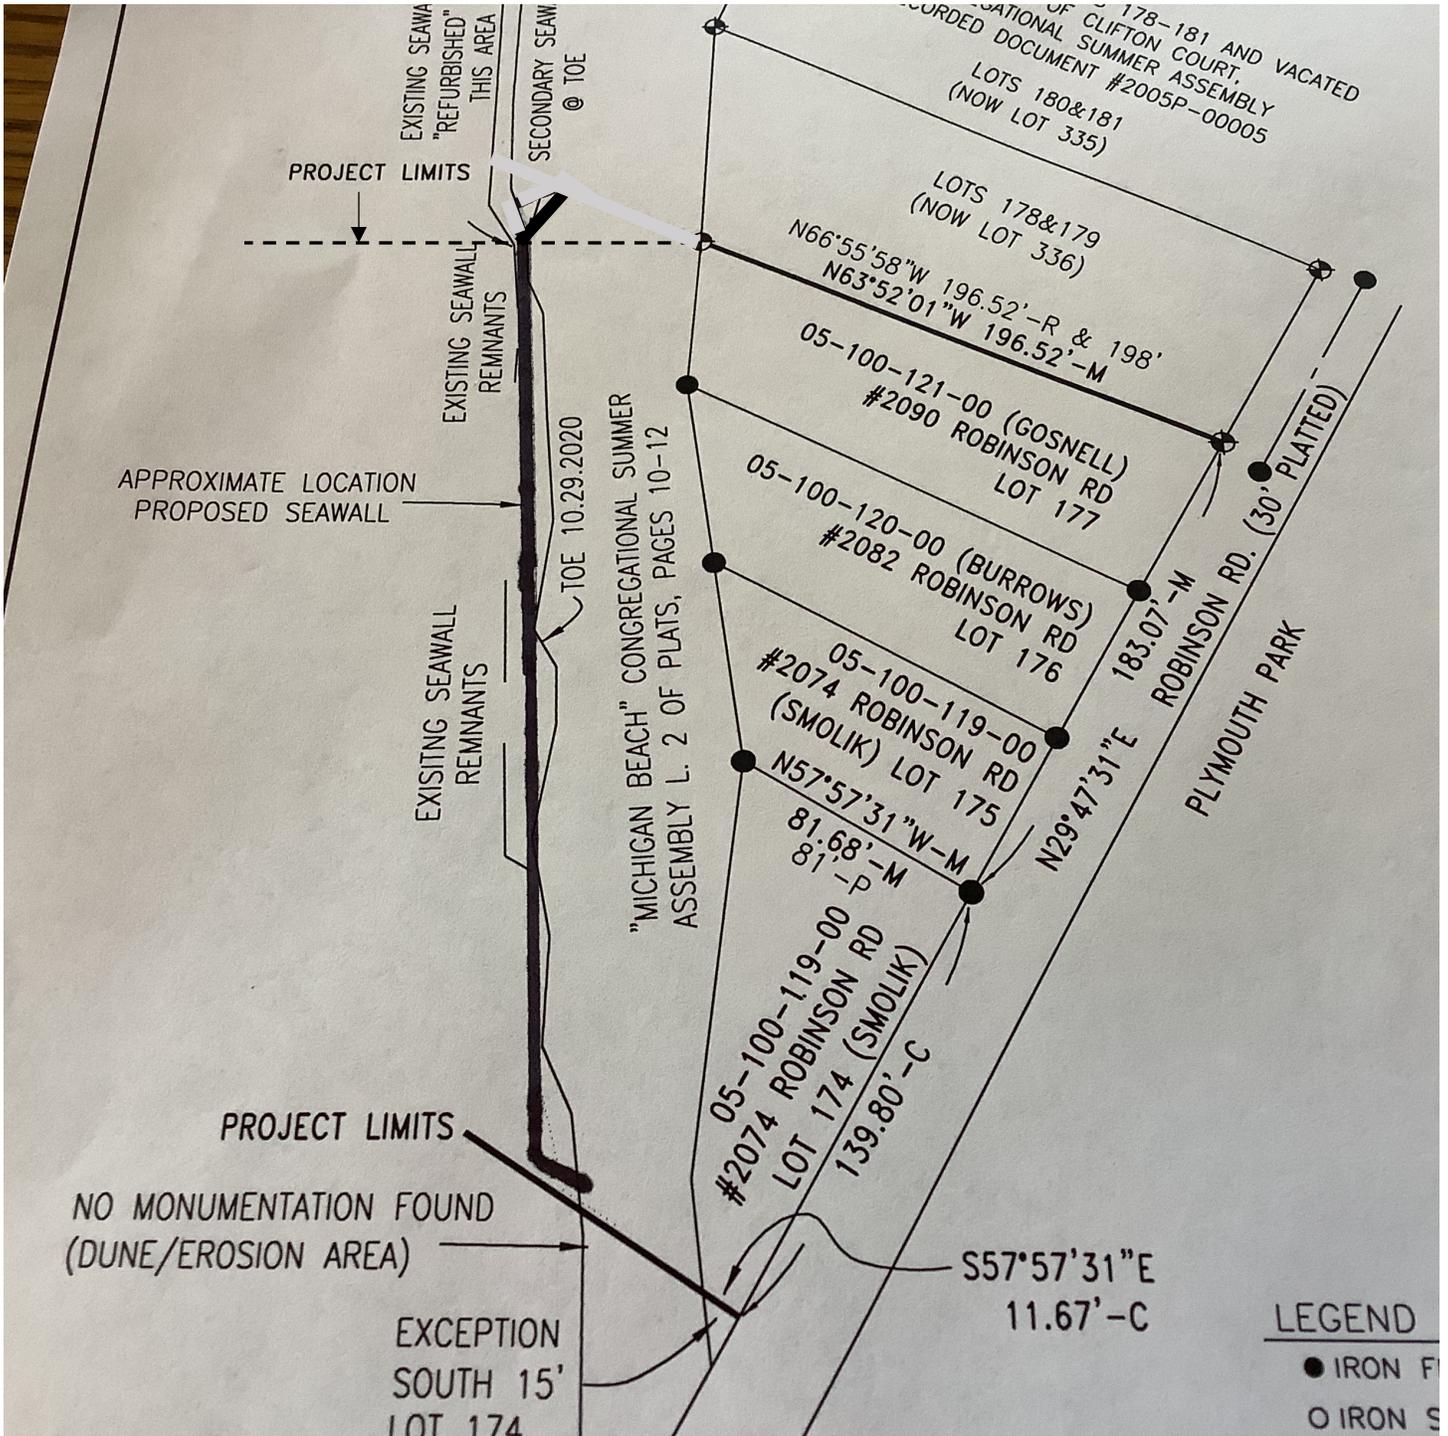
Figure Three Survey With New Sea Wall Highlighted

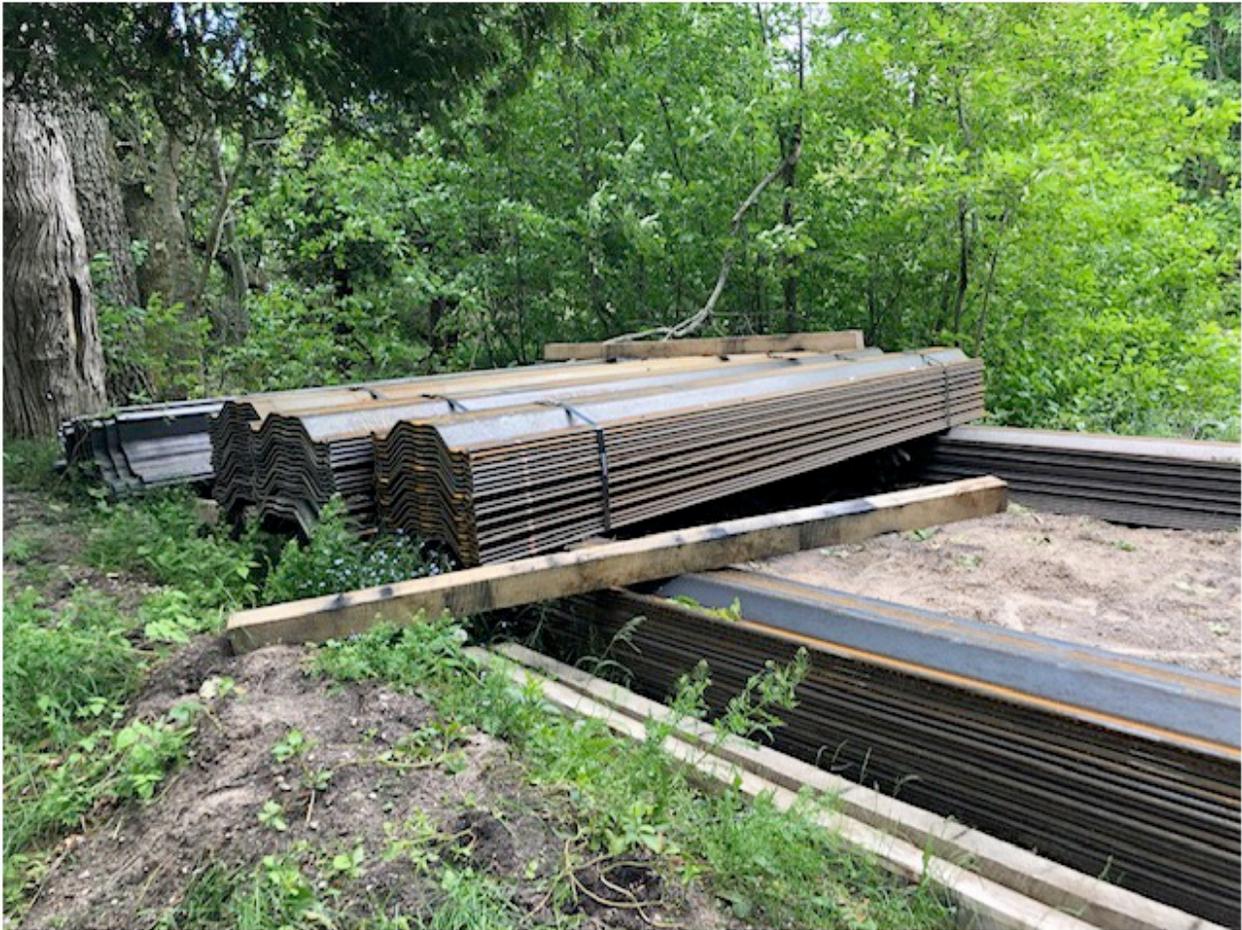
Figure Four
Sheet Pile Steel Pieces
Prior to Installation

Construction Figure Four depicts the sheet pile pieces before construction. They are 15' high, 5 ga steel. Figure Five shows the Wildewood wall installed. During construction, the pieces are vibrated into the sand, embedding them about 11' into the sand, with 4' of wall remaining exposed. Every 10' or so where possible the wall is tied back to the landward side to maximize structural stability. See Figure Six of the presentation for a depiction.

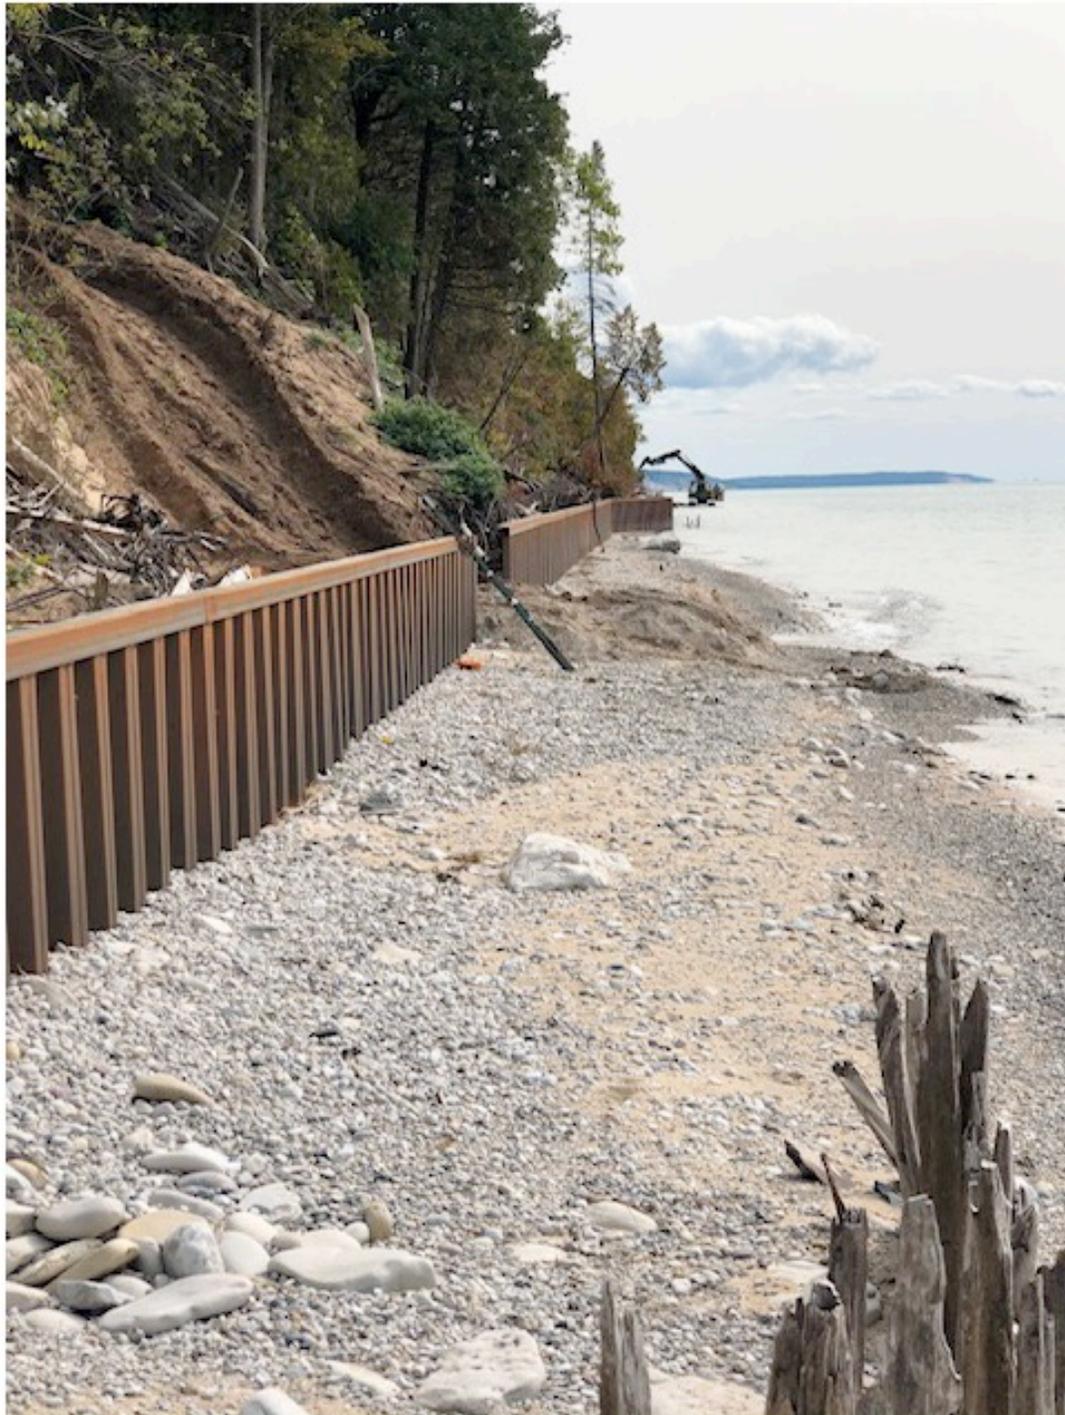
Figure 5
Wildewood Sheet Pile
Sea Wall
(looking south)

↑
4'0" High +/-
↓

During placement of the sea wall, rocks, tree branches, roots and the like will likely be uncovered. These will be deposited on the landward side of wall, as seen in Figures five and Six. All man-made garbage will be cleaned up and removed. In addition, any damage caused by the construction equipment to the CSA beach property will be fully remediated by the Owners and their contractor.

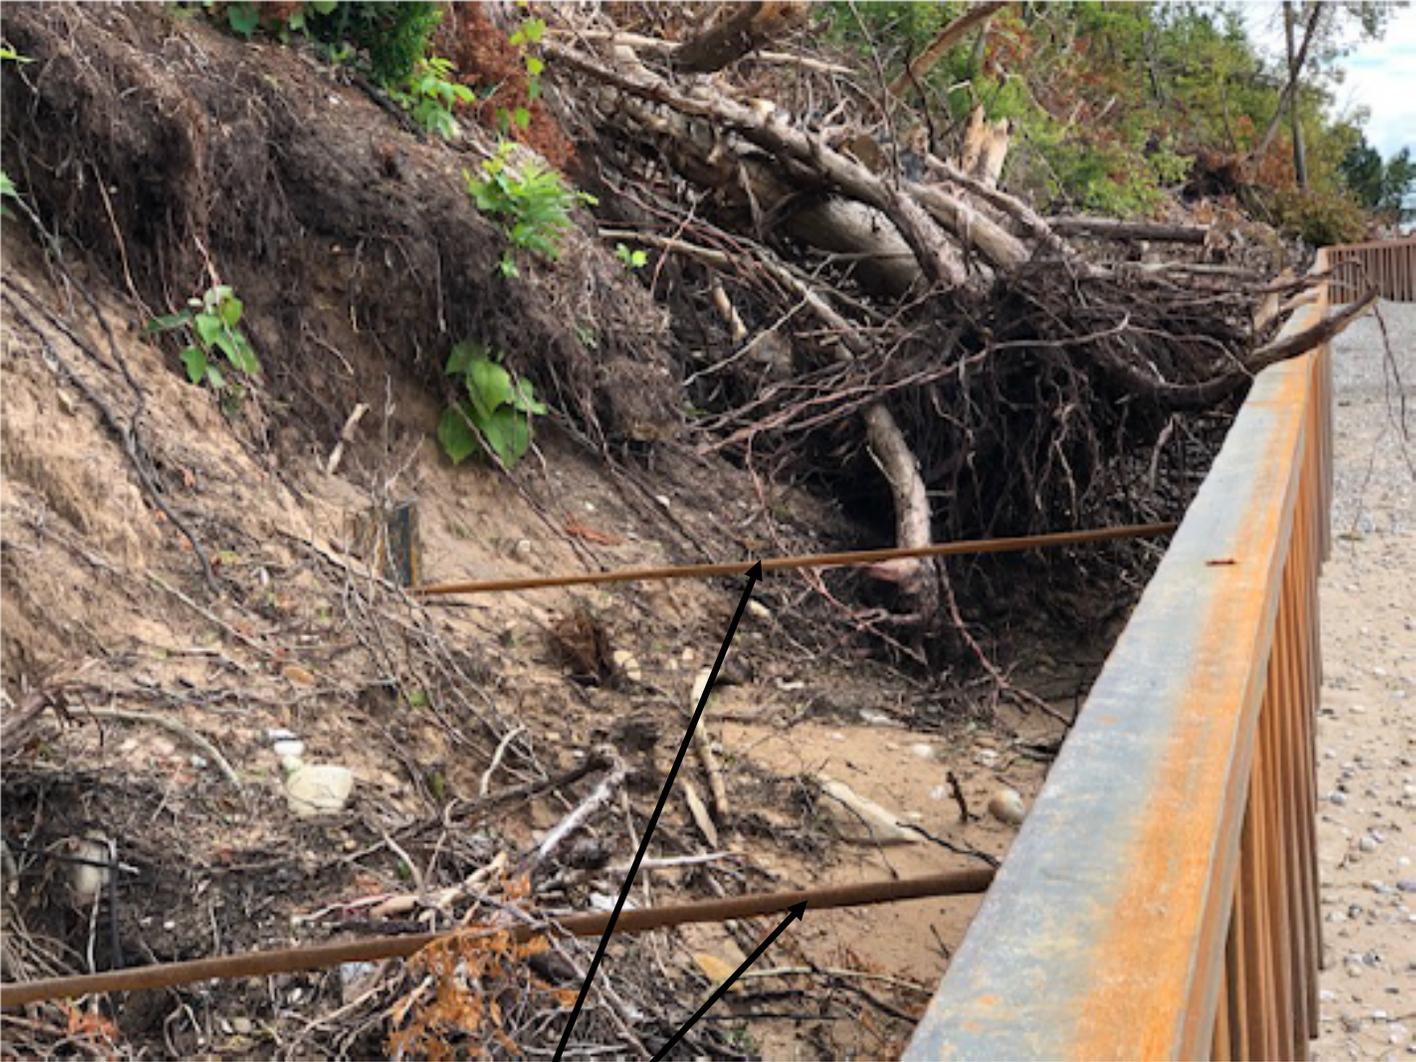
Figure Six
Wildewood Sea Wall
Showing Tie-Backs
(looking south)

Tie -Backs

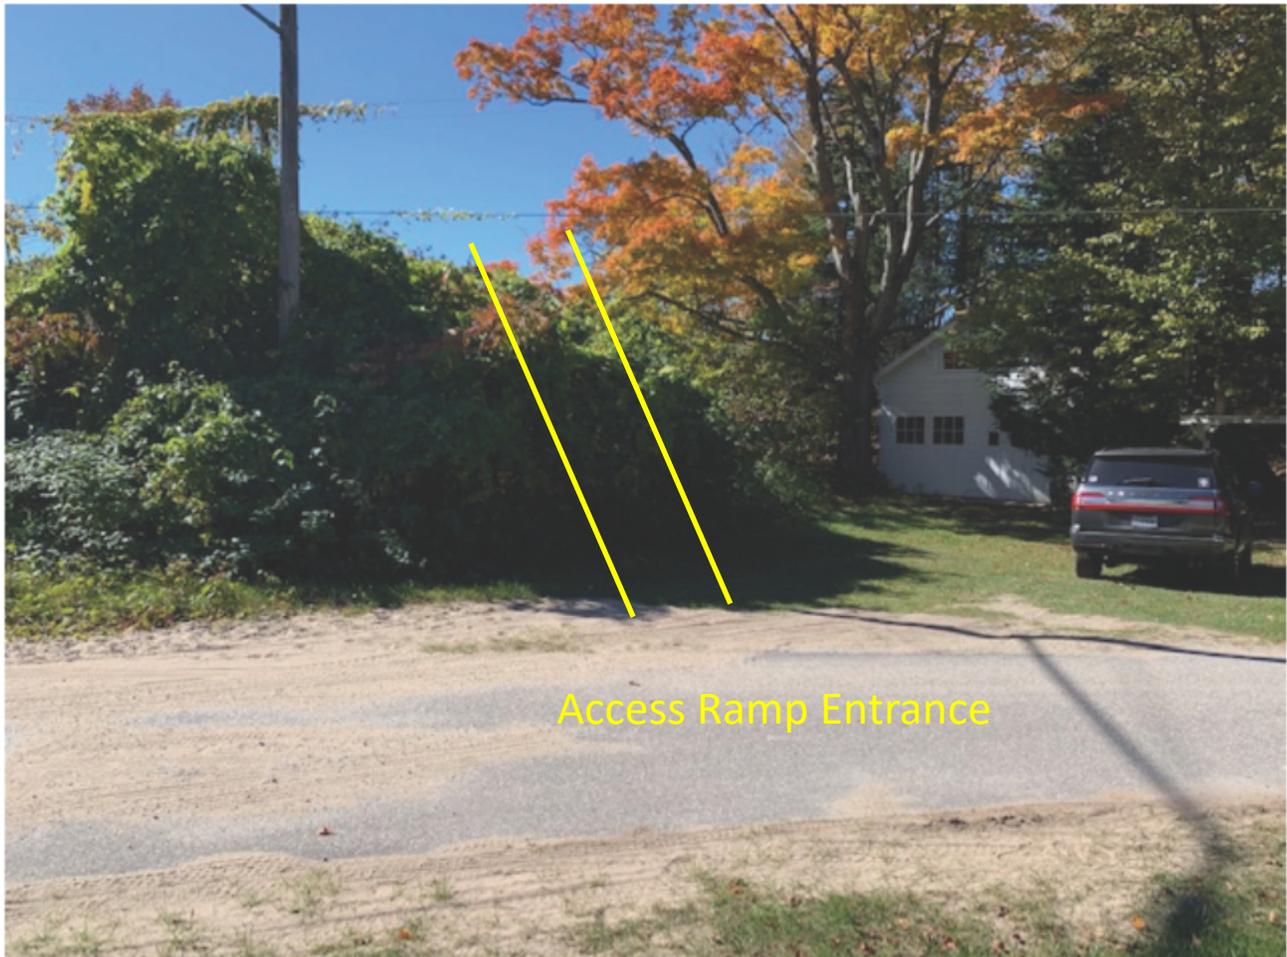
Figure Seven
Access Ramp
Looking West

Construction Access As part of the project, because of their extended frontage, the Smolik family has offered to allow beach access through their property, specifically Lot 174. See Figures Seven through Nine of the presentation for a visual depiction of the access location. The Owners have agreed to jointly fund a full remediation of this access point once construction has completed, in accordance with the requirements of our permits. In addition, although we do not anticipate this, should any damage occur to CSA inland property during the project, the Owners will have this remediated as well.

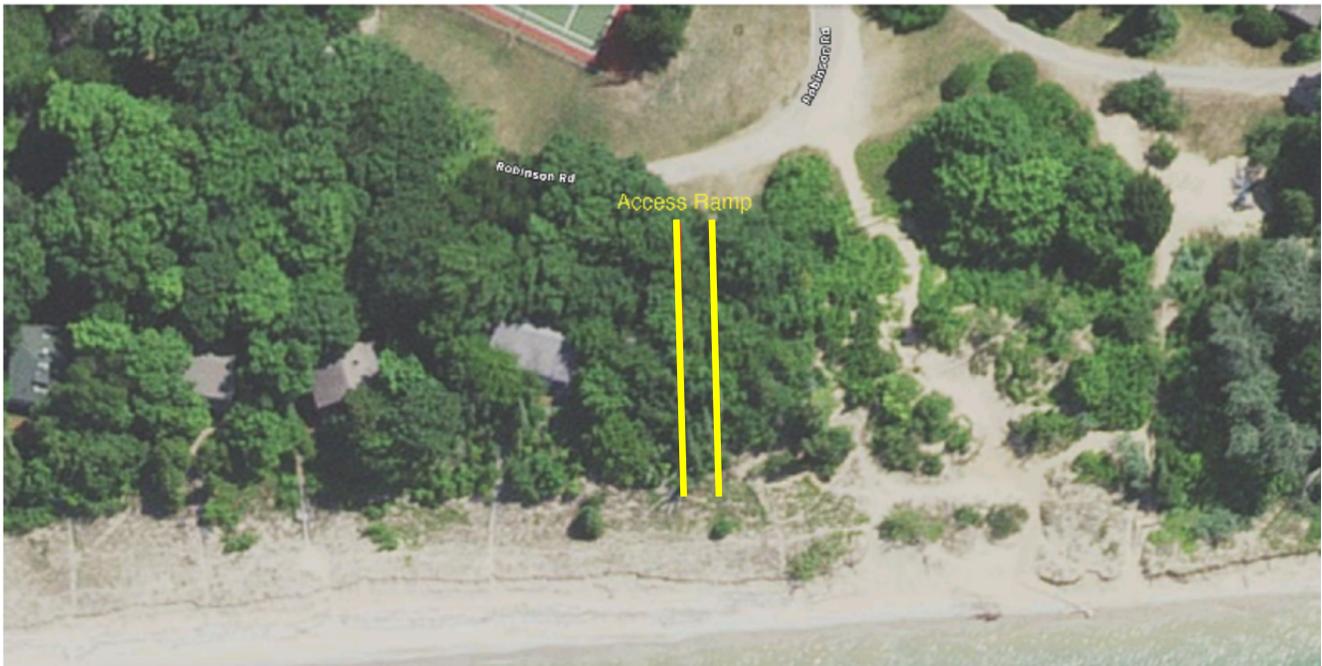
Figure Eight
Access Point
Overhead View

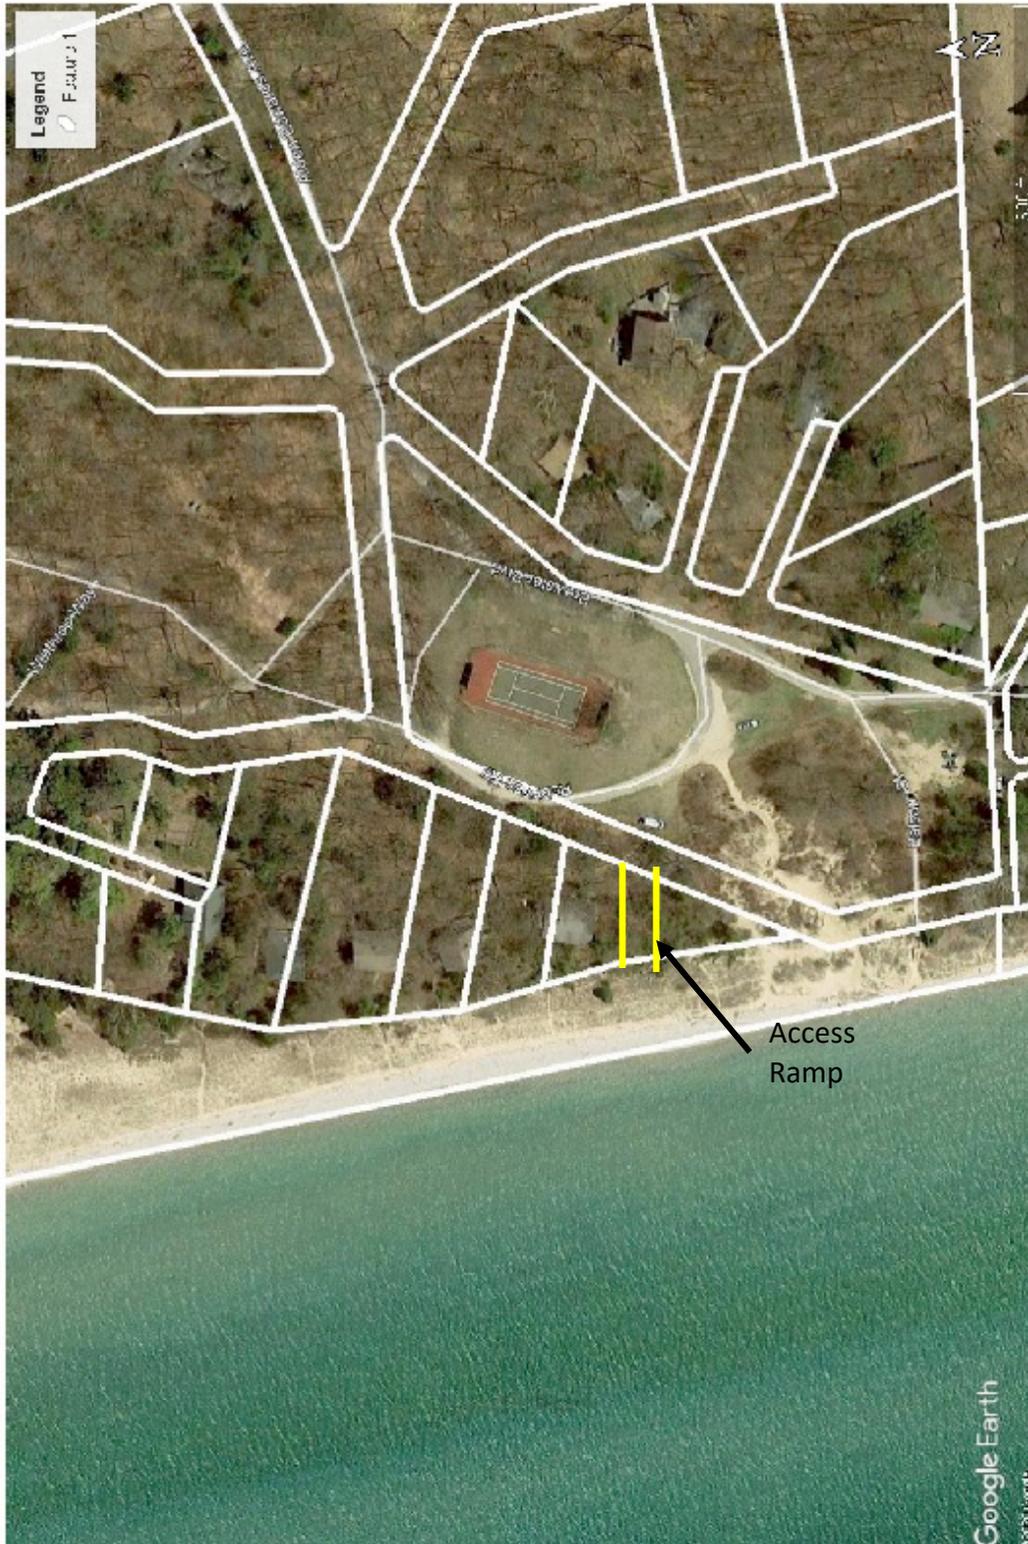
Figure Nine
Access Ramp
Aerial View
Showing Lot Lines
